## Collapsed Drain/Ground Stabilisation.

The south end of an existing building was to be refurbished into a new dining area. Prior to commencement of this work remedial work to an existing collapsed foul drain that runs below the ground slab was carried out.

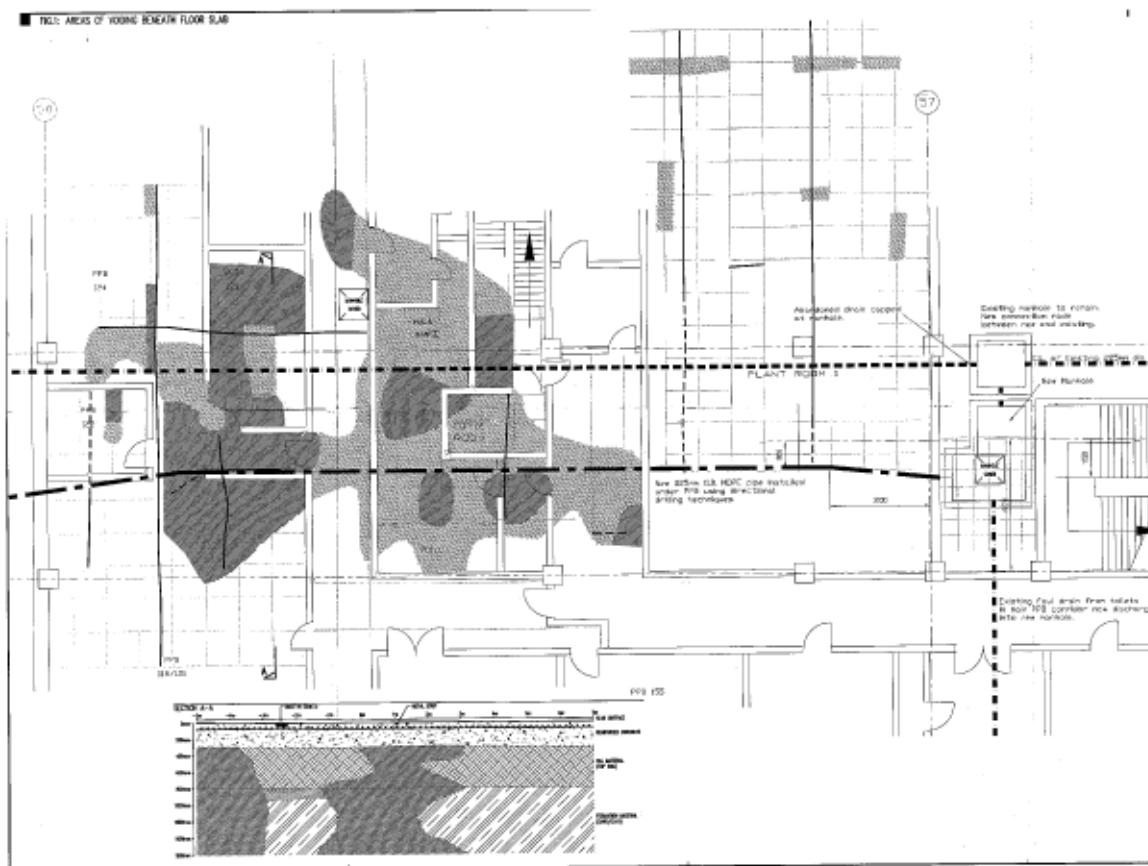
Surveys of both the drain and the underlying ground were carried out using Radio detection and impulse radar. The results of the surveys indicated voiding in the supporting ground and that the existing drain had settled. The survey highlighted an area of voiding of approximately 600m<sup>2</sup> within the supporting ground. The depth of voiding was limited to 1.6m below slab level (i.e. the max range of the Impulse radar equipment).

The unsound ground was stabilized by drilling a series of small diameter holes and injecting, to a depth of up to 2.5m, a specialist expanding foamed concrete. The stabilization was carried out extremely quickly in only 4 days. There was no disruption to surrounding areas still in production occurred.

With regard to the remedial work to the drain itself, a pumping chamber was located in the North courtyard of the building and the effluent pumped down a new smaller diameter MDPE pipe installed through the existing recently installed failed pipe. This solution was considered most practical especially from a safety viewpoint as it had the following advantages over a traditional gravity fed installation.
