LMAC Avoidance

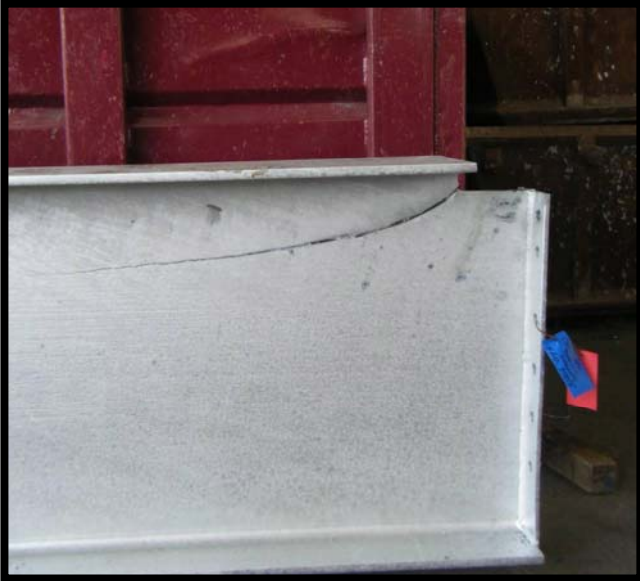
Fig 1 – A Major LMAC Failure

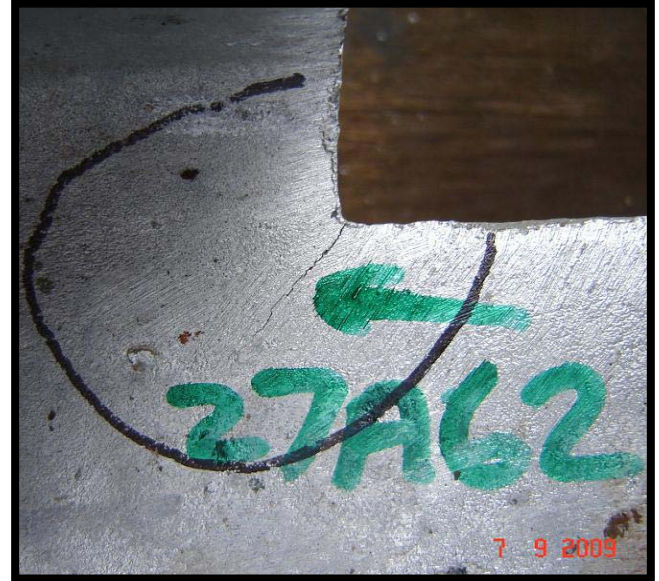
Fig 2 - Bad Notch Detail

1. Material Control - The Tin content in the bath should be less than 0.1%.
2. High grade steels are more prone to cracking i.e. S355 vs. S275.
3. Consider higher sub-grades such as JO or J2 on key elements.
4. Notching in the 'K' zone (route where web meets flange) is a major cause as this is the area of most residual stress due to rolling. The larger the notch radius the less chance that LMAC will occur (See Fig 2).
5. Ensure that the Galvaniser you choose is fully aware of LMAC problems and has a suitable inspection procedure in place.
6. Some failures are so fine that they are hard to spot at first glance. The crack shown in fig 2 is less than 0.5mm wide and only 20mm long.
7. In addition to the Galvaniser checking have your own QA inspectors check for LMAC. A missed crack could have major consequences for a key element within a structure!
