LED Replacement Tubes – Office Areas

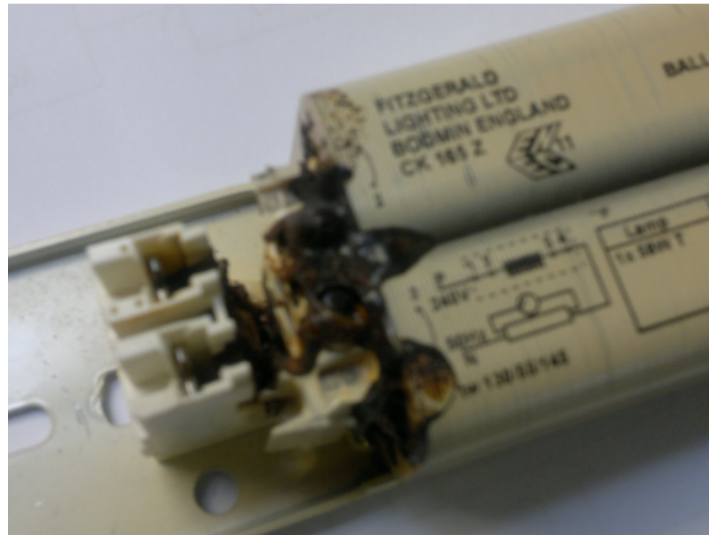
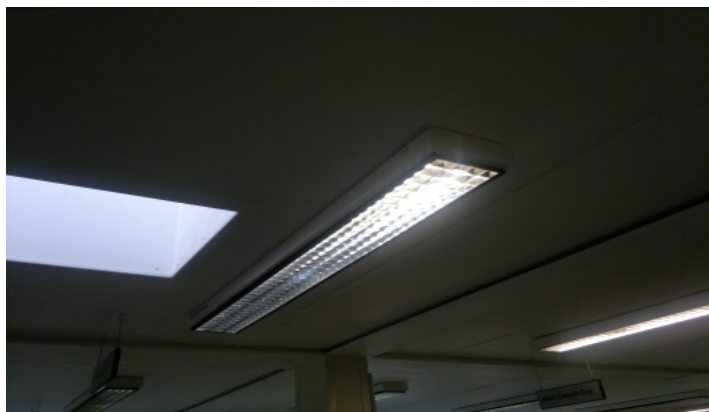
LED replacement tubes have recently been installed on a pharmaceutical production site. Some office areas had suffered from several older types of T8 fluorescent fittings overheating causing a fire risk. On investigation it was found that it was the magnetic ballasts that were overheating.

A cost comparison was carried out between replacing the fittings completely, or replacing the conventional discharge tubes with LED tubes which do not require a ballast. It was found to be more cost effective to install LED tubes and carry out a small wiring change on the fitting.
