Thermal Breaks in Practice

Following on from case study DBP00071 Peers Steelwork have recently completed a project where the use of “Schoek” thermal insulators was a specific design requirement. Below is a list of key points which may prove useful for anyone thinking of using a similar product.

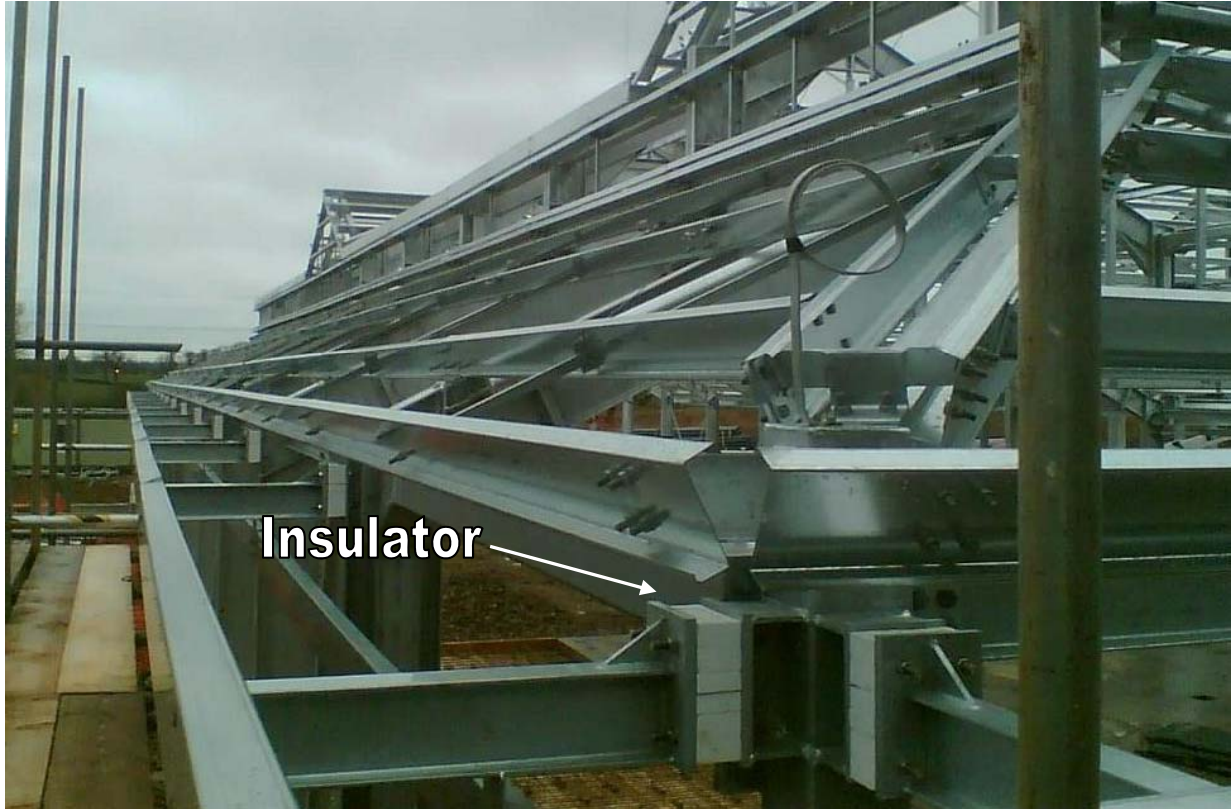
1. The insulators were required to form a break in the overhanging eaves on a new portal frame lab structure.
2. The design of the actual joint was indicative only and Peers liaised with Schoek and were responsible for the final joint design.

3. Schoek’s catalogue is quite in depth with regard to the various types of joints, design guides and test data for the various joint types.
4. The thickness requirements for the end plates is much greater than a normal steel to steel connection as distortion resistance is critical and double curvature bending can not be assumed. This may lead to stub pieces and thick plates being welded to column flanges.

5. The units came in pairs with each unit (2 bolts) costing £65. The additional stubs and thicker plates gave a joint cost of £180 per location (Mar 08). This may well be more expensive than providing additional insulation especially in the case of cantilever beams supporting a fully clad soffit.
