DESIGN POOR PRACTICE – Clearance around CHW brackets

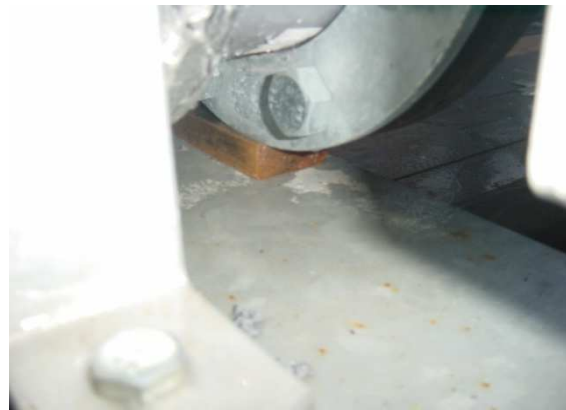
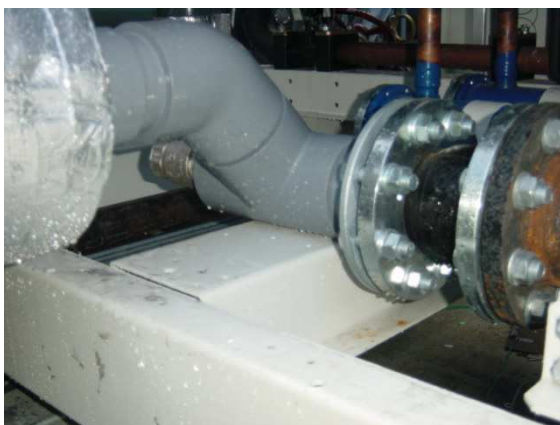
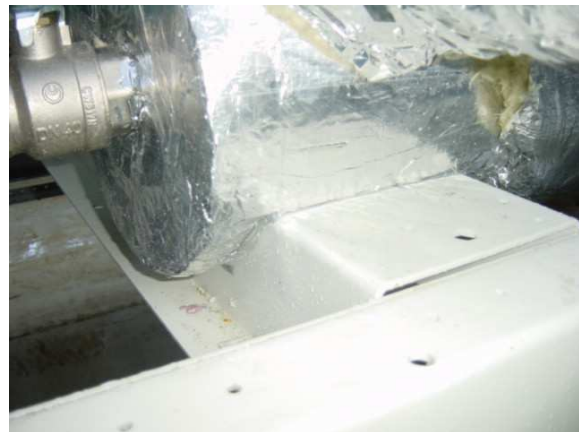
Poor design of the pipework system around brackets and unistrut framework on a Chilled Water system means that clearance for the insulation is insufficient and unless the insulation thickness can be applied to the manufacturers specification, a vapour seal cannot be achieved and the system will continuously cause condensation “sweating” and corrosion.

- However good the workmanship, any attempt to create a vapour seal around the pipework / fitting is futile and a cold bridge forms causing condensation & therefore corrosion will occur.
- The efficiency of the Chiller Unit will be affected (causing energy loss) as the chiller will be over compensating for the lost “cold” around the affected area.
- The cold bridge allows moisture into the vapour-sealed system and can cause extensive corrosion requiring remedial / replacement works.
- If Design Engineers were to liaise with the insulation contractor at early design stage, these issues could be designed out and increase the efficiency of plant and reduce issues on-site which cost time & money.
