# Fragile Domed Rooflight Refurbishment

To refurbish the existing stained glass fragile domed roof-light to prevent water ingress and allowing backlit illumination.

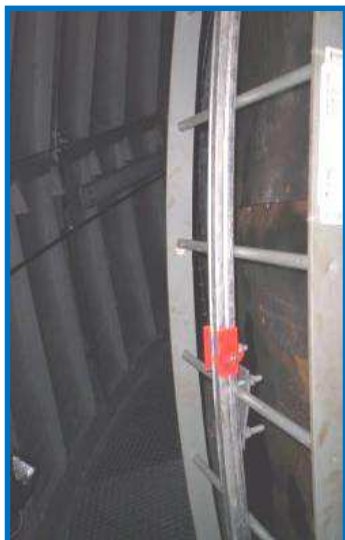
*Curved Rotating Ladder + Slide-lock*

- A glass fibre outer dome was installed by crane for weatherproofing.
- The inner glass domed roof-light was repaired from a birdcage scaffold within the auditorium.
- Maintenance walkway installed between the two domes with a high level fall restraint cable fixed to the outer dome.
- Access to the upper curved areas of glass is via a curved ladder gantry with a slidelock harness attachment.
- Easily accessed light fittings fitted at low walkway level reflect off the underside of the outer dome to illuminate the rooflight.

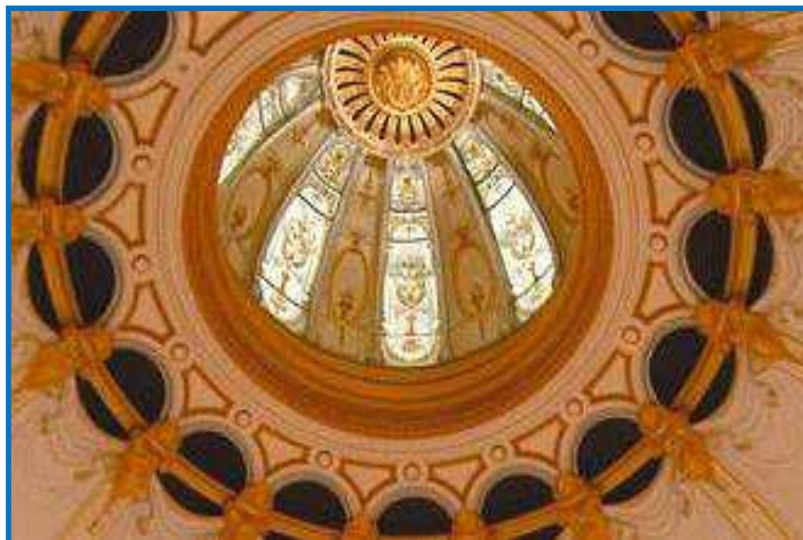
*Rooflight from Below*

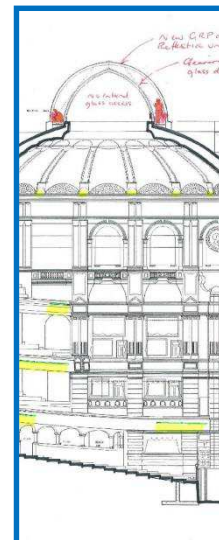
*7-storey Auditorium with Dome & Rooflight*

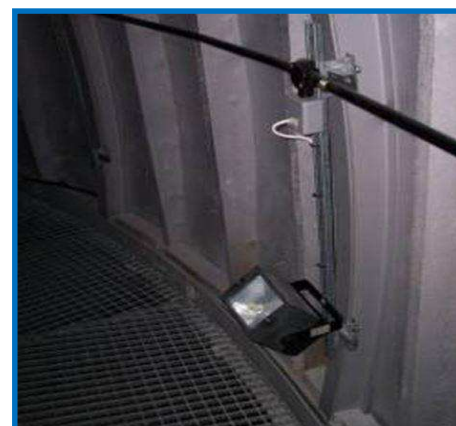
*Walkway & Up-Light*
