# Managing Internal Riser Ducts - Design Examples

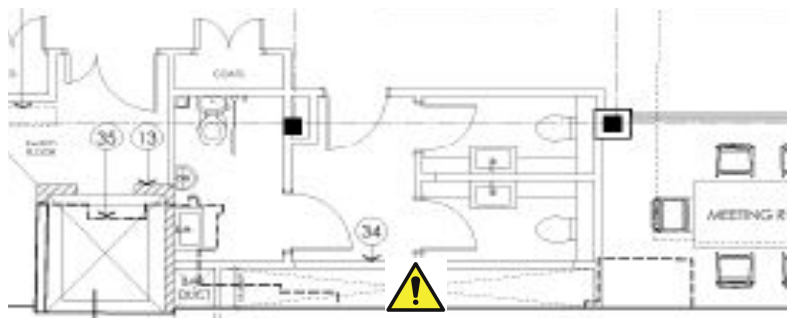
Large duct at party wall, fall risk highlighted

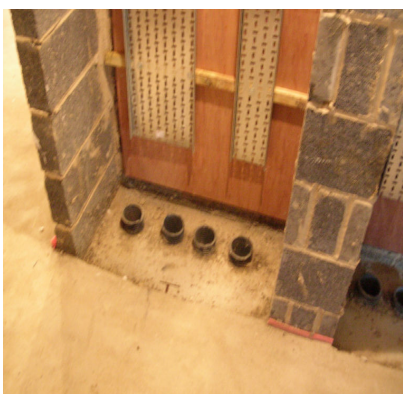
1. Sleeved services

The designer alerted the contractor to the issue at tender on drawings. Where it was possible, the risers were kept adjacent to walls, making them easier to protect. Co-ordination between M & E designers and structural designers was required to reduce the size of riser openings. Sleeves or ducts were cast in ready for services. The concrete frame contractor was also consulted to cast mesh into the floor plate (See 3 above). Because they had been appointed early, the M&E contractors could be consulted to agree their preferred solution.

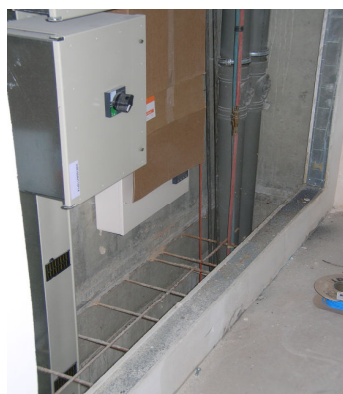
2. Large metal mesh

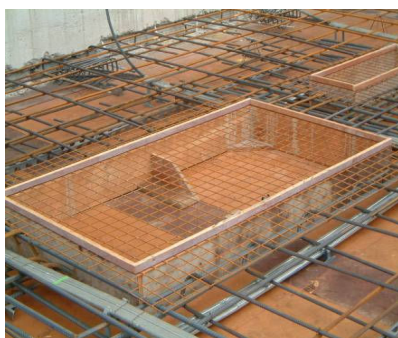
3. Small cast-in metal mesh prevents falls in open areas (though standing on it as pictured may not be advised)
